BUILDING SURVEY

PROPERTY ADDRESS	Address withheld xxxxxxx xxxxxxx Northamptonshire NN6 xxx
CLIENTS NAME	Client name withheld
CLIENTS ADDRESS	Client address with xxxxxxx xxxxxxx xxxxxxx
DATE OF INSPECTION	2 October 200
NAME OF SURVEYOR	Francis, FRICS DipHI
NAME OF COMPANY	Homesurv Ltd
ADDRESS OF COMPANY	Catherine House Old Harborough Road Brixworth NORTHAMPTON NN6 9BX
TELEPHONE	01604 882522
FAX	01604 882924
EMAIL	russell@homesurvuk.com

SPECIMEN REPORT

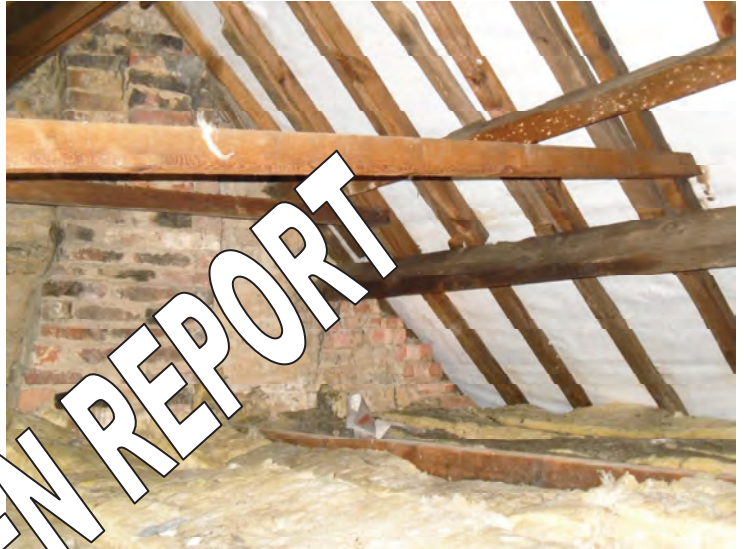
The overhauled slate roof covering has been underdrawn with a breathable and untearable roofing felt. This work has been undertaken recently and the underfelt is in good condition.

Main roof structure and new lining to main roof covering

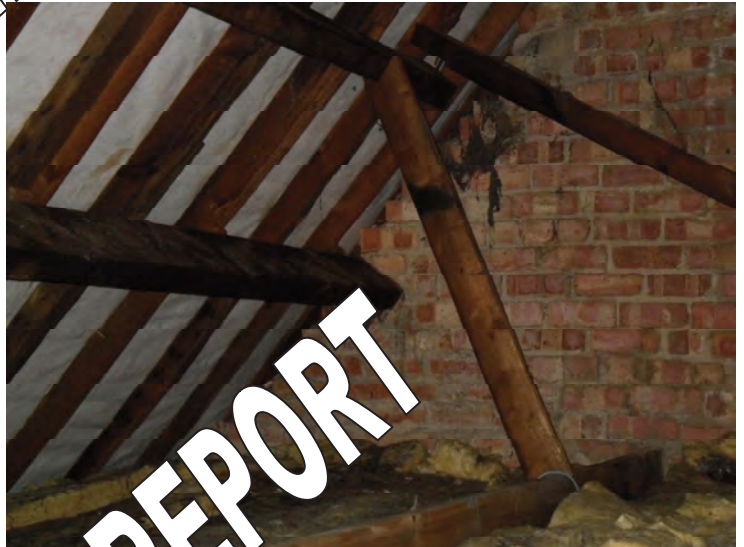
Additional purlin supported by additional struts

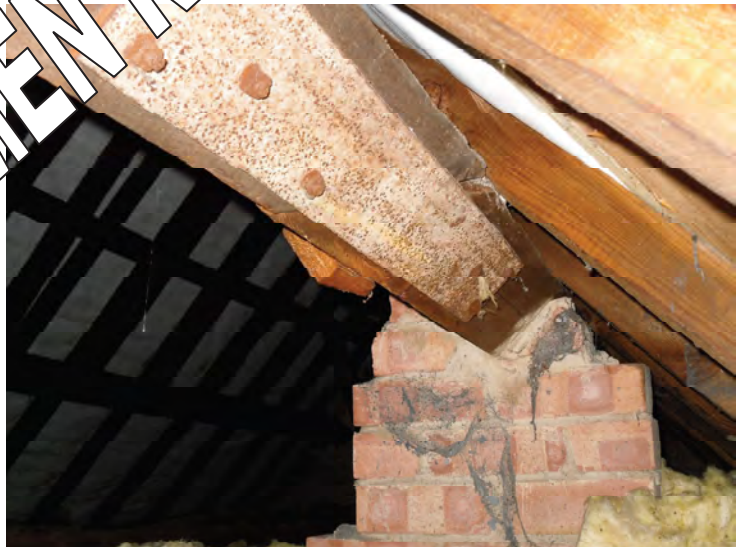
Metal plate to purlin and brick partition wall
